Dive Report

Subject: Submission of Dive Report

Attached is the Dive Report for the Underwater Examination of the Structures and Collection of Sediment Samples at Iron Gate, Copco 1, and JC Boyle Dams which was performed by the PN Regional Underwater Inspection Team from April 12 through 16, 2010.

Iron Gate Dam, Klamath Hydroelectric Project, California

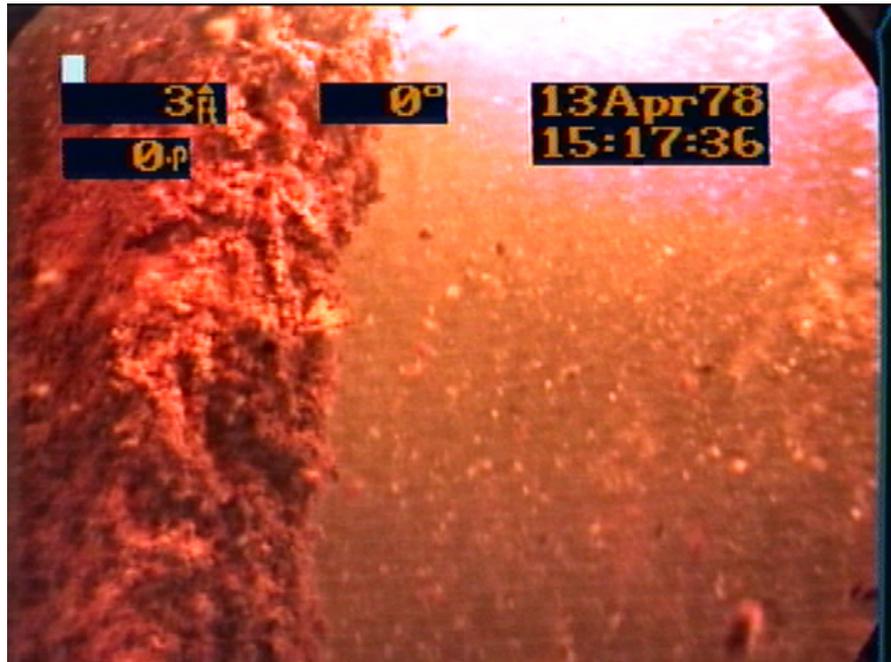
Photograph No. 9. ROV captured video image showing example of organic debris coating the trashrack bars on the outlet intake structure at Iron Gate Dam (Note: Date, time, and depth readings are not accurate). PN Regional Underwater Inspection Team – JC Boyle, Copco 1, and Iron Gate Dams, Klamath Hydroelectric Project, Oregon – California – April 12-16, 2010.

The intake structure at Iron Gate Dam should be periodically inspected by ROV to determine if the rust nodules and algae growth are increasing with time, possibly reducing the structure's capacity to release flows. At this time it did not appear the capacity of the intake structure is reduced. The intake concrete appeared to be in satisfactory condition.

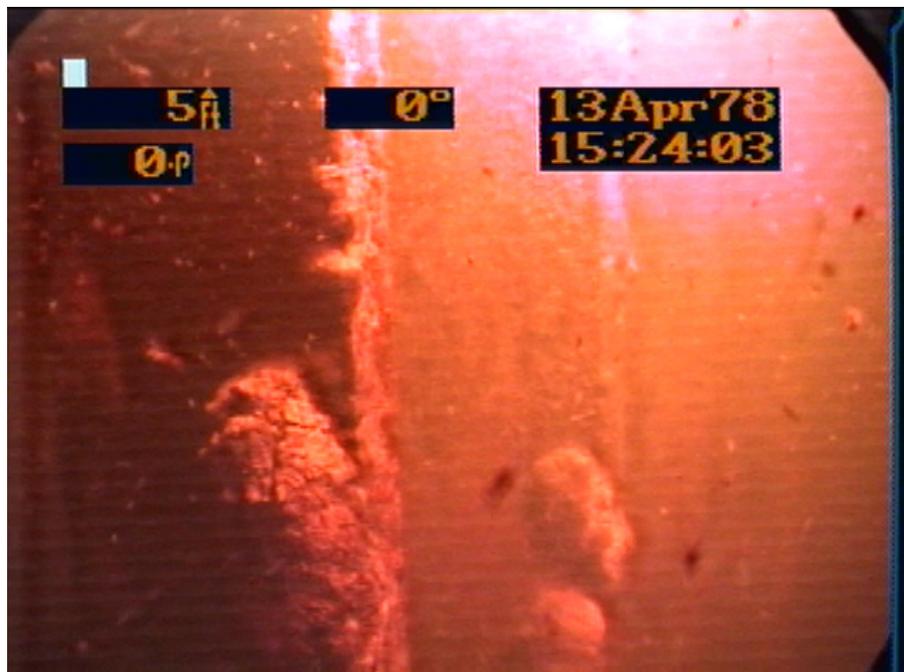
Photograph No. 10. ROV captured video image showing example of rust nodules found on trashrack surface. (Note: Date, time, and depth readings are not accurate). PN Regional Underwater Inspection Team – JC Boyle, Copco 1, and Iron Gate Dams, Klamath Hydroelectric Project, Oregon – California – April 12-16, 2010.

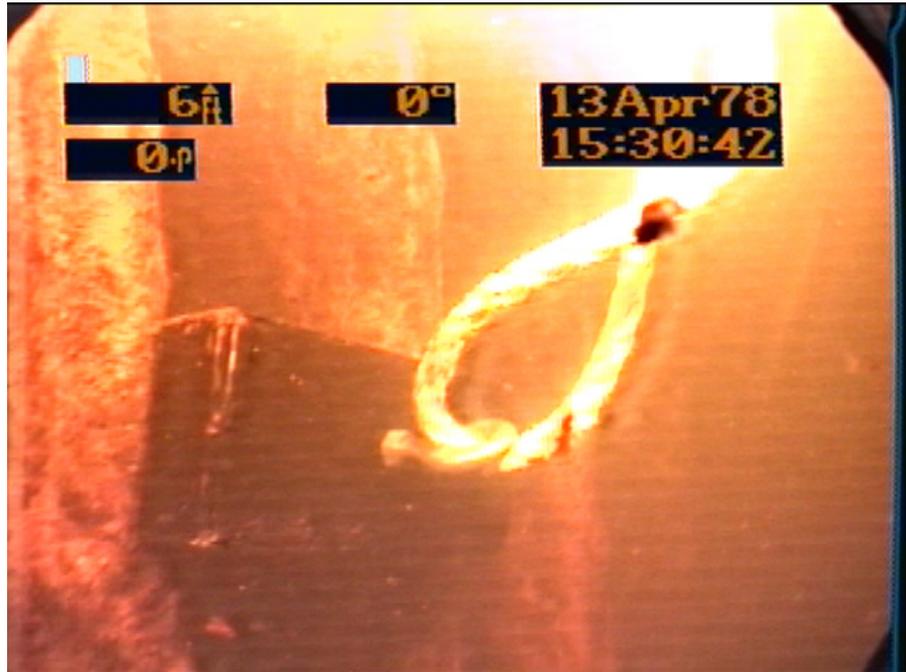
The team then moved downstream to conduct the intake structure inspection. The dive team located the intake structure by boat using bottom scanning sonar in conjunction with “fishing” for the metallic trashracks with a large magnet. Refer to Photograph No. 4 and Drawing G-8692. Once located, the intake structure coordinates were recorded to be 122° 26.1219’ N, 41° 56.1462’ W. The trashracks protecting the intake structure were inspected with an ROV, (refer to Photograph Nos. 5 through 8) due to depth limitations of divers on SCUBA equipment. The trashracks are all covered with ¼-inch of organic matter, refer to Photograph No. 9. Approximately 15 feet of the upper portion of the intake structure is free of sediment and debris. The lower section is silted in with fine organics and sediments. A very small amount of woody debris, up to 3 inches, was observed. The trashracks had minor rust nodules covering 5 to 10 percent of their surface. Some nodules looked to be 2 to 3 inches in diameter and up to 1 inch in height, refer to Photograph No. 10. The concrete appeared to be in very good condition with no spalling or scaling. The top of the intake structure had approximately 3 to 4 inches of fine sediment and debris. Photograph No. 11 shows the “fishing” magnet secured to the side of the intake structure.

Photograph No. 11. ROV captured video image of fishing magnet attached to steel trashrack bars of outlet intake at Iron Gate Dam (Note: Date, time, and depth readings are not accurate). PN Regional Underwater Inspection Team – JC Boyle, Copco 1, and Iron Gate Dams, Klamath Hydroelectric Project, Oregon – California – April 12-16, 2010.

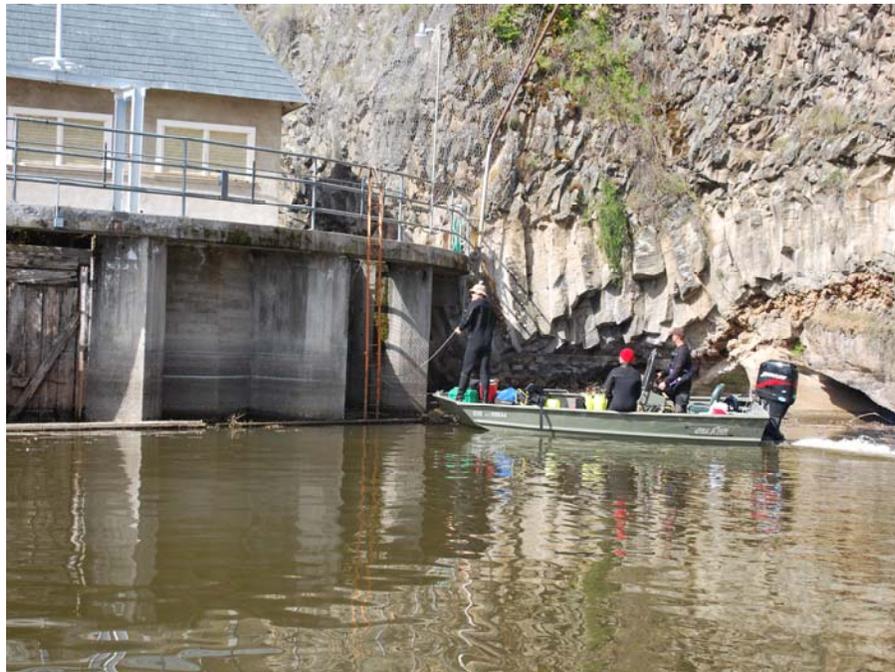
Divers moved downstream to the face of the dam and performed an inspection of the powerplant intake structure to the right of the radial gates. Refer to Photograph Nos. 12 and 13 and Drawing G-8692. Divers reached a maximum depth of 21 feet on the power intake structure. The limited visibility did not allow the divers to take photographs of the structure. Woody debris up to 3-inches in diameter and approximately 12-foot deep was encountered by divers. The second bay looking downstream had a slightly higher amount of woody debris collected. The concrete had

minor spalling on leading edges that was felt by hand. A ¼-inch deep covering of algae was noted on all concrete surfaces. The trashracks were 100 percent covered with rust and rust nodules up to ½-inch in diameter and ¼-inch high were noted. A steel L-bracket was found across bay 2 from pier to pier with no apparent purpose.

Photograph No. 12. Dive team securing boat for dive inspection of powerplant intake structure at Copco 1 Dam. PN Regional Underwater Inspection Team – JC Boyle, Copco 1, and Iron Gate Dams, Klamath Hydroelectric Project, Oregon – California – April 12-16, 2010.

The power intake structure at Copco 1 Dam is severely clogged with woody debris. The woody debris should be removed so this material is not ingested by the turbines. In addition, if the debris is not removed it may significantly reduce the facility's ability to generate power. Overall the concrete structure is in good condition with no spalling or exposed rebar noted.

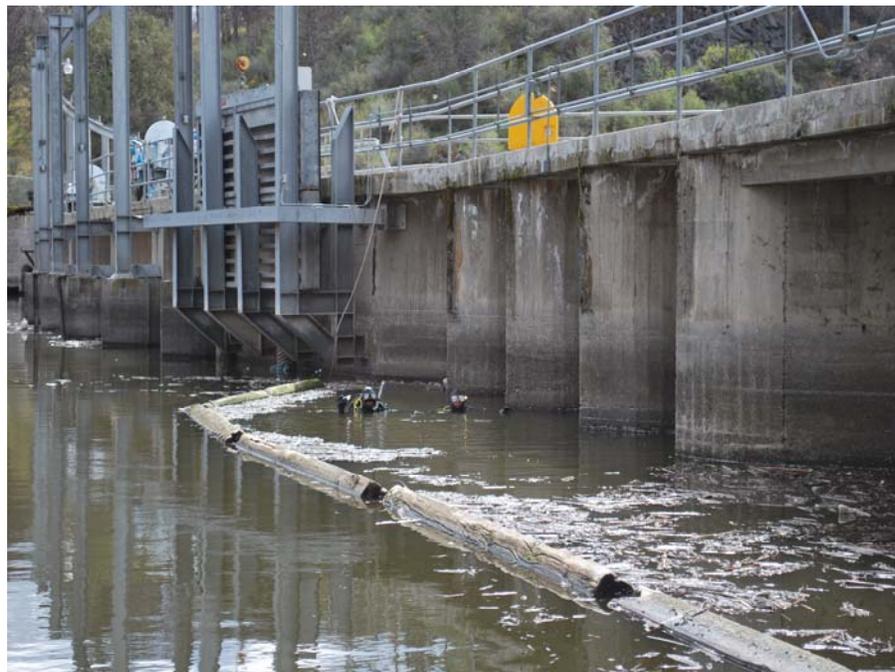
Photograph No. 13. Divers on surface relaying findings of dive inspection of the powerplant intake at Copco 1 Dam. PN Regional Underwater Inspection Team – JC Boyle, Copco 1, and Iron Gate Dams, Klamath Hydroelectric Project, Oregon – California – April 12-16, 2010.

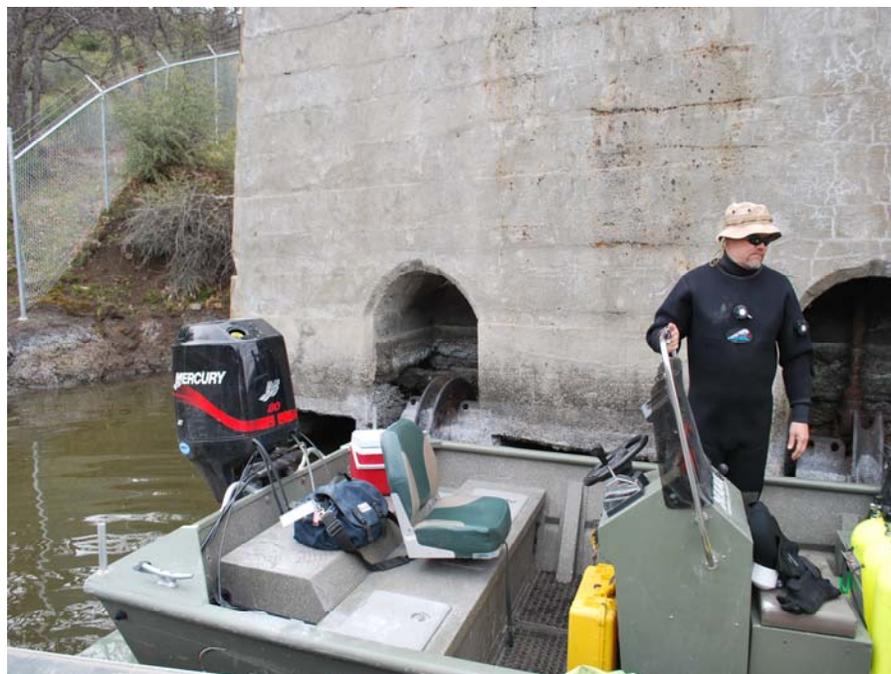
The diversion intake was surveyed by divers to a maximum depth of 42 feet. Refer to Photograph Nos. 14 through 16 and Drawing F-1370. Divers encountered very limited visibility and were only able to survey the structure by touch. Divers found what appeared to be the cables used to open and close the abandoned intake structure valves. The cables are 100 percent covered in rust and buried in silt. As divers proceeded deeper they encountered increasing amounts of gravel up to 4 inches in diameter and boulders that ranged from 12- to-18-inches in diameter. A large amount of woody debris was also discovered up to 6-inches in diameter. Due to the deep depths the ROV was dispatched in an attempt to survey the intake structure on the bottom. Due to the limited visibility adequate references for driving the ROV were not possible. Therefore, the intake structure was not found and no further information could be collected.

Photograph No. 14. Dive boat secured at right abutment near abandoned low-level intake control structure at Copco 1 Dam. PN Regional Underwater Inspection Team – JC Boyle, Copco 1, and Iron Gate Dams, Klamath Hydroelectric Project, Oregon – California – April 12-16, 2010.

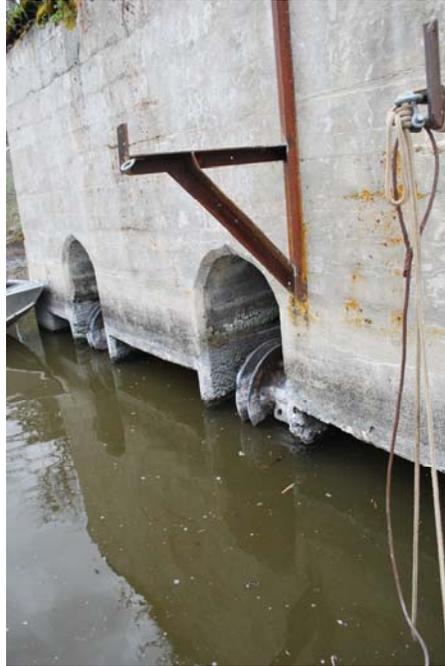
Photograph No. 15. Cable roller device for abandoned low-level intake structure at Copco 1 Dam. PN Regional Underwater Inspection Team – JC Boyle, Copco 1, and Iron Gate Dams, Klamath Hydroelectric Project, Oregon – California – April 12-16, 2010.

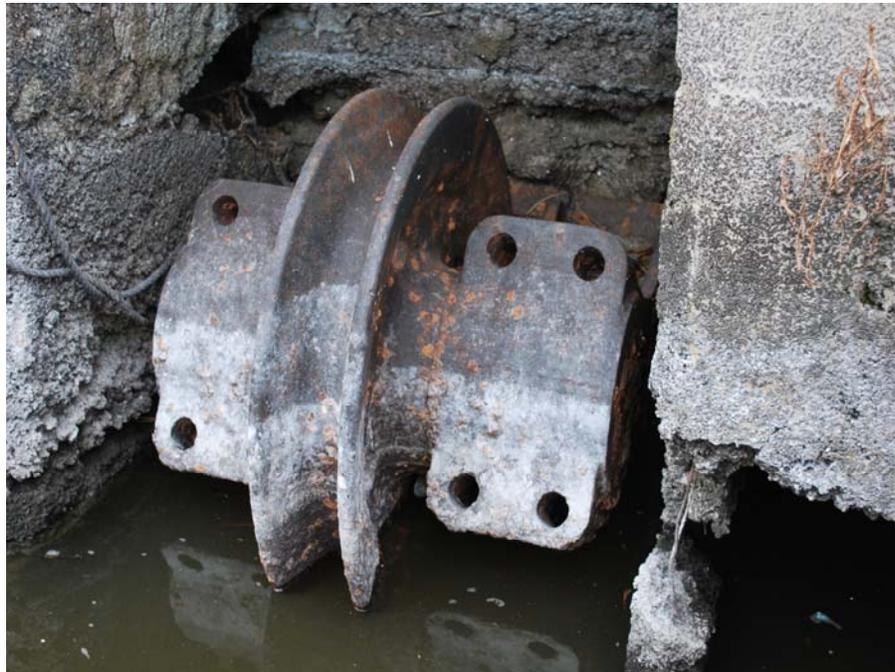
Photograph No. 16. Close-up of roller for abandoned low-level intake structure at Copco 1 Dam. PN Regional Underwater Inspection Team – JC Boyle, Copco 1, and Iron Gate Dams, Klamath Hydroelectric Project, Oregon – California – April 12-16, 2010.

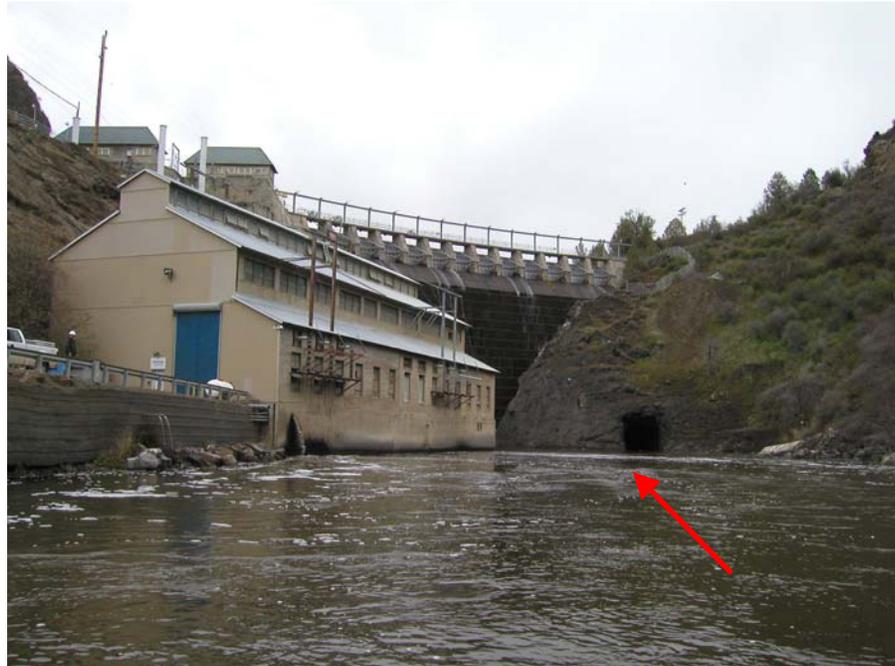
The dive team proceeded downstream to Copco 2 reservoir. The team launched a boat to survey the diversion tunnel and concrete plug in Copco 1 Dam. Refer to Photograph Nos. 17 through 19 and Drawing F-1439. The boat was able to float approximately 95 feet up the tunnel before requiring an on-foot approach to the concrete plug, refer to Photograph No. 20. The total length of the tunnel is approximately 189 feet. The concrete plug is approximately 14.5-feet wide and 20-feet high. The concrete plug is concave in the middle approximately 18 inches upstream and the center square is approximately 7-feet by 7-feet, refer to Photograph No. 19. On the centerline at the bottom is a 3-foot-by 3-foot opening in the concrete. Inside the opening is a rusted steel valve, refer to Photograph No. 21. On top of the concrete plug is what appears to be a grout pipe that is now flowing water. Flows from the grout pipe are estimated to be approximately 15-20 gallons per minute, refer to Photograph No. 22. There is a significant amount of leakage at the concrete-rock interface along the outer sides of the concrete plug, refer to Photograph No. 23.

Photograph No. 17. Upstream view of Copco 1 Dam. On left side is powerplant generator structure. On right side (red arrow) shows abandoned low-level outlet tunnel. Divers made a boat assisted surface inspection of concrete plug. PN Regional Underwater Inspection Team – JC Boyle, Copco 1, and Iron Gate Dams, Klamath Hydroelectric Project, Oregon – California – April 12-16, 2010.

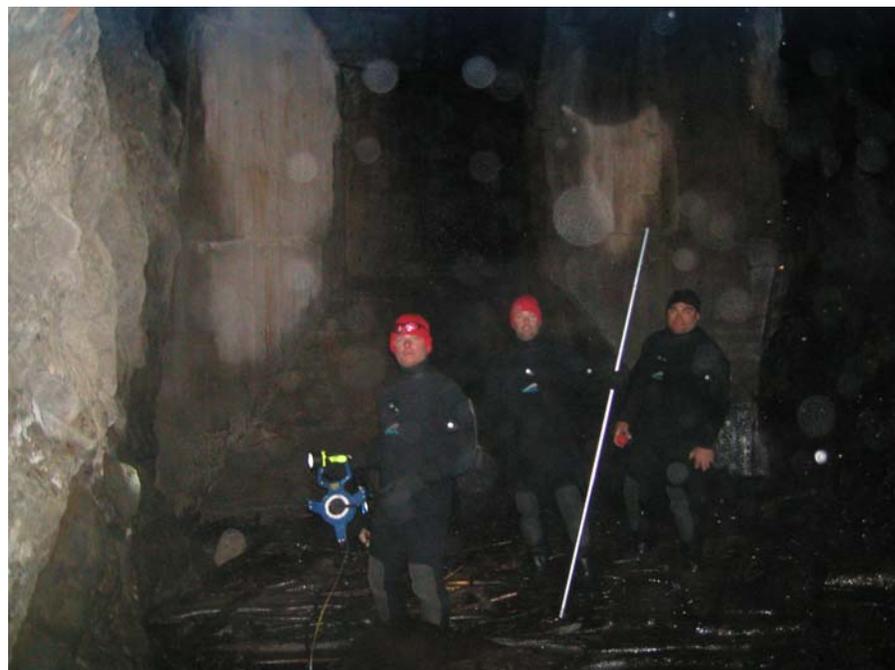
Photograph No. 18. Divers standing at furthest most point accessible next to concrete plug, making field measurements.. PN Regional Underwater Inspection Team – JC Boyle, Copco 1, and Iron Gate Dams, Klamath Hydroelectric Project, Oregon – California – April 12-16, 2010.

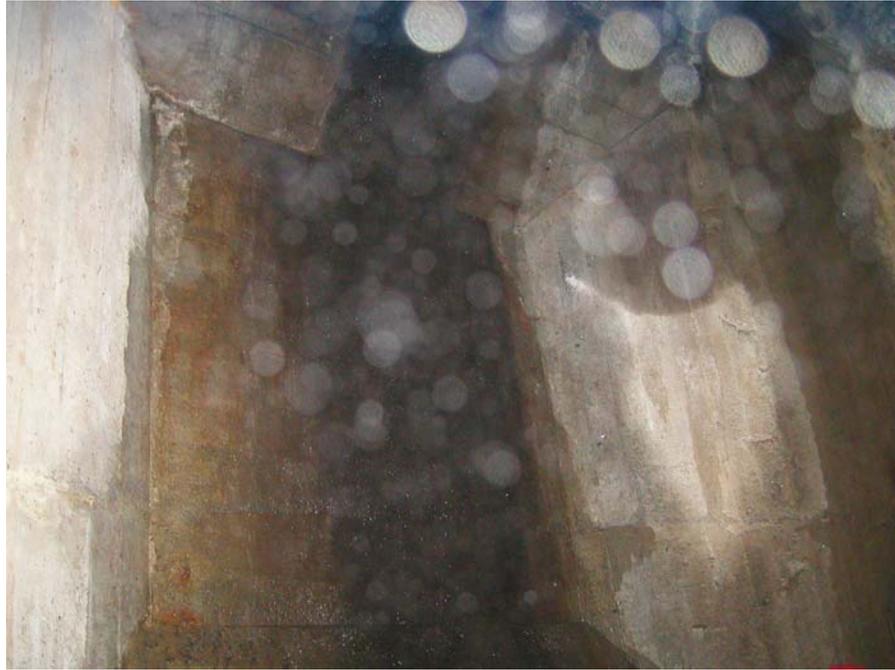
Photograph No. 19. Close-up view of concrete plug in the abandoned low-level outlet tunnel at Copco 1 Dam.. PN Regional Underwater Inspection Team – JC Boyle, Copco 1, and Iron Gate Dams, Klamath Hydroelectric Project, Oregon – California – April 12-16, 2010.

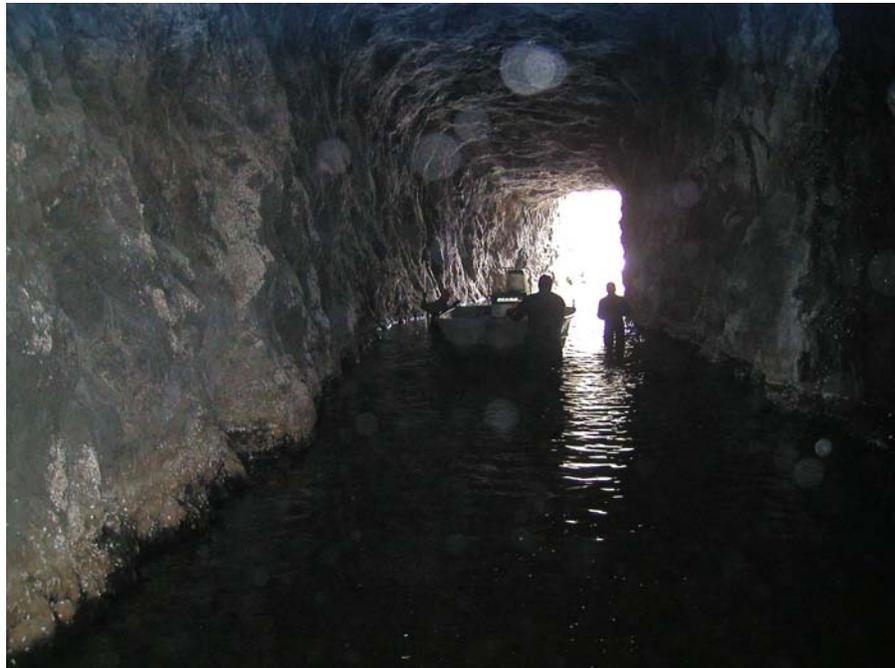
Photograph No. 20. View of low-level outlet tunnel looking downstream to portal. PN Regional Underwater Inspection Team – JC Boyle, Copco 1, and Iron Gate Dams, Klamath Hydroelectric Project, Oregon – California – April 12-16, 2010.

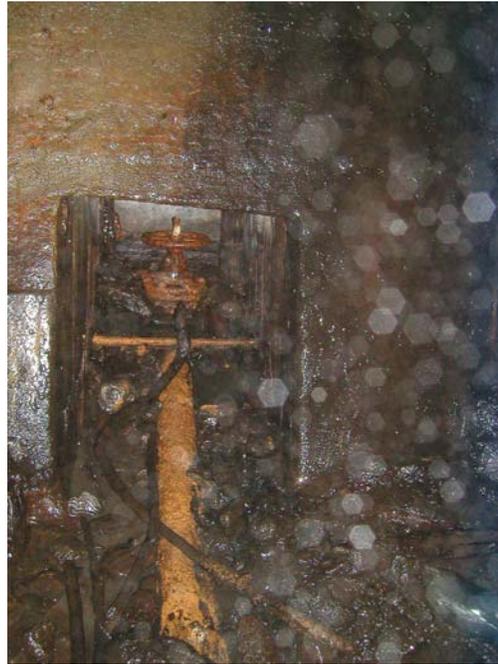
Photograph No. 21. Rusted gate valve located at bottom of concrete plug in the abandoned low-level outlet tunnel at Copco 1 Dam. PN Regional Underwater Inspection Team – JC Boyle, Copco 1, and Iron Gate Dams, Klamath Hydroelectric Project, Oregon – California – April 12-16, 2010.

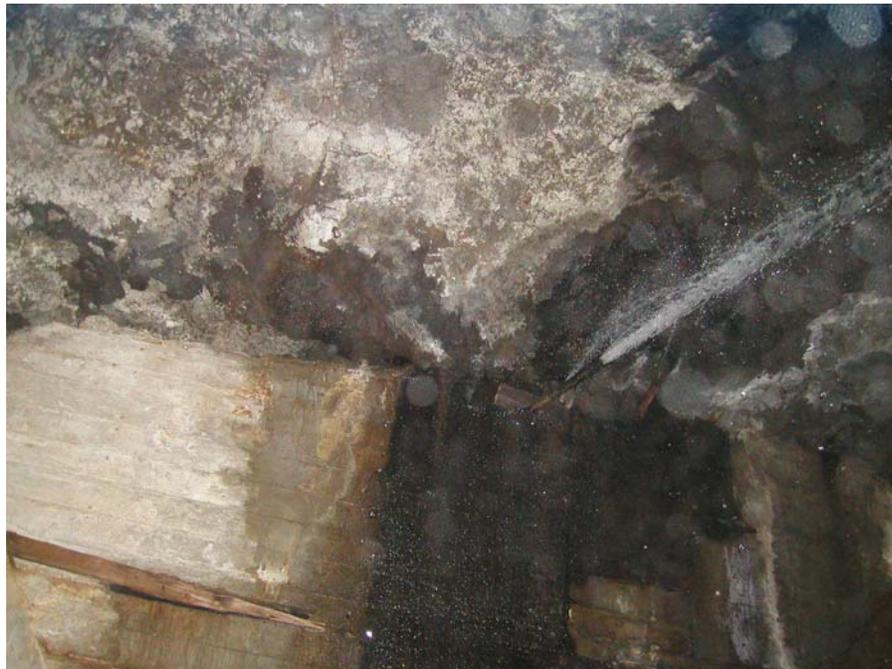
Photograph No. 22. View at top of concrete plug. Pipe at top of plug releasing water at approximately 15 to 20 gpm. PN Regional Underwater Inspection Team – JC Boyle, Copco 1, and Iron Gate Dams, Klamath Hydroelectric Project, Oregon – California – April 12-16, 2010.

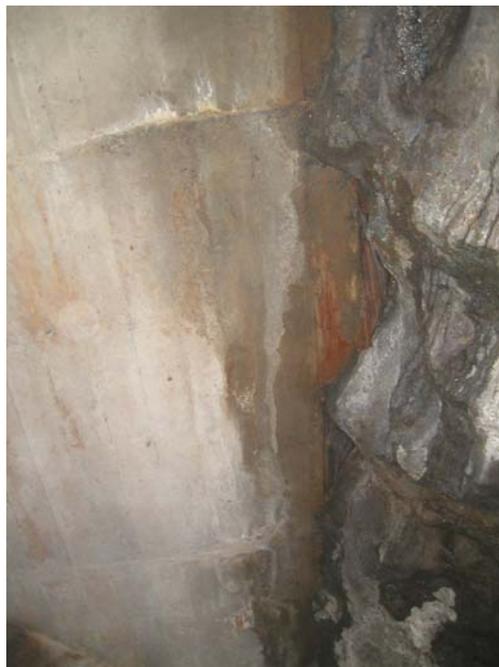
Photograph No. 23. Concrete plug interface with rock tunnel in the abandoned low-level outlet tunnel at Copco 1 Dam. PN Regional Underwater Inspection Team – JC Boyle, Copco 1, and Iron Gate Dams, Klamath Hydroelectric Project, Oregon – California – April 12-16, 2010.

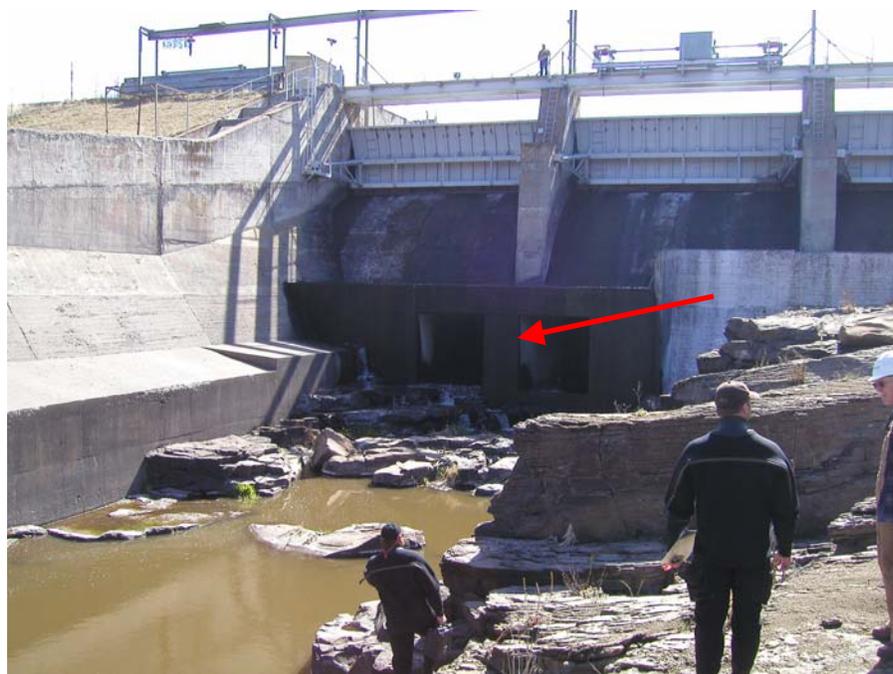
The dive team proceeded downstream to perform a topside inspection of the downstream portion of the double barrel diversion conduit, refer to Photograph No. 24. The conduit measurements are approximately 9½-feet-wide, 10-feet-high, and 40-feet to the stoplogs face. Looking downstream the left side conduit shows signs of very little leakage, refer to Photograph Nos. 25 through 27. The right side conduit has significant leakage as also discovered by divers underwater due to the stoplogs being racked in the guide channel, refer to Photograph Nos. 28 through 31. Flows through the right side are approximately 20 gallons per minute. Measurements of the racked stoplogs show there is a 1¾-inch offset from the top of the second stoplog. A probe of the gap allowed a plumbers rule to enter the gap by as much as 21 inches before significant resistance was noted.

Photograph No. 24. View looking upstream at double barrel diversion conduit (red arrow) used during construction of JC Boyle Dam. PN Regional Underwater Inspection Team – JC Boyle, Copco 1, and Iron Gate Dams, Klamath Hydroelectric Project, Oregon – California – April 12-16, 2010.

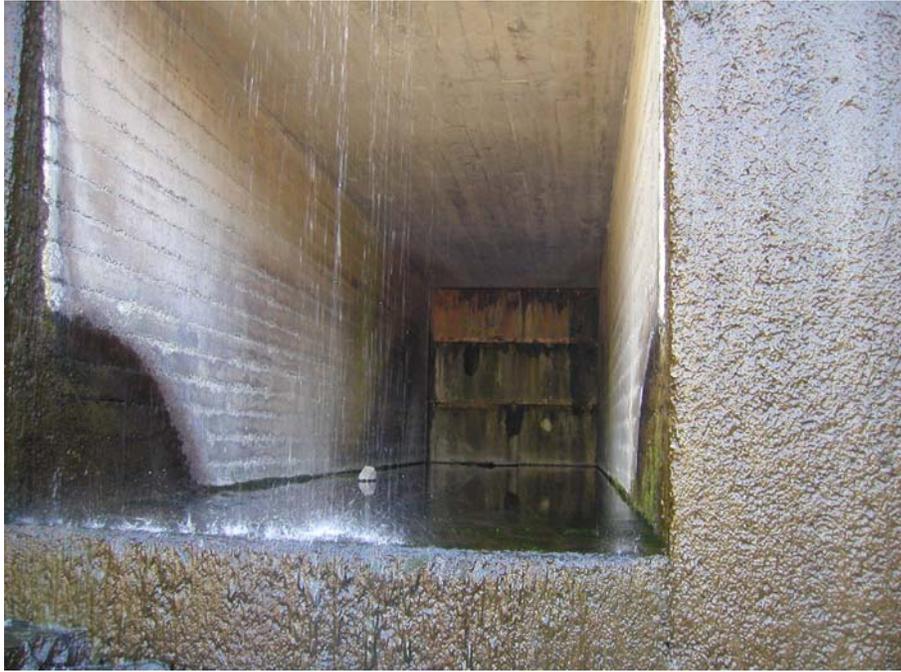
Photograph No. 25. View looking upstream at left double barrel diversion conduit. PN Regional Underwater Inspection Team – JC Boyle, Copco 1, and Iron Gate Dams, Klamath Hydroelectric Project, Oregon – California – April 12-16, 2010.

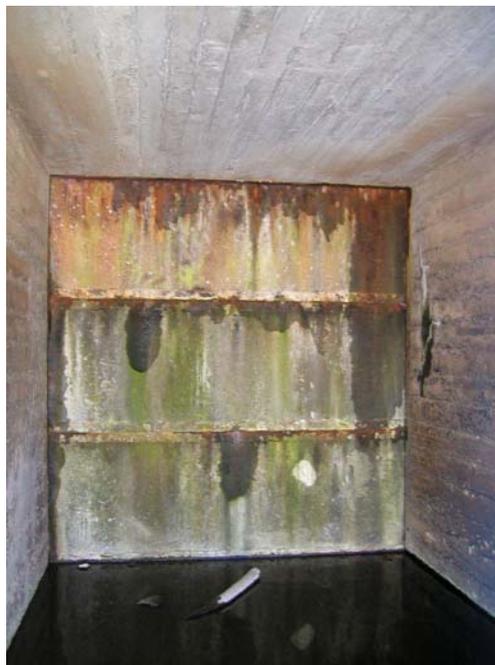
Photograph No. 26. Upstream view of stoplogs in the left side of the double barrel diversion conduit. PN Regional Underwater Inspection Team – JC Boyle, Copco 1, and Iron Gate Dams, Klamath Hydroelectric Project, Oregon – California – April 12-16, 2010.

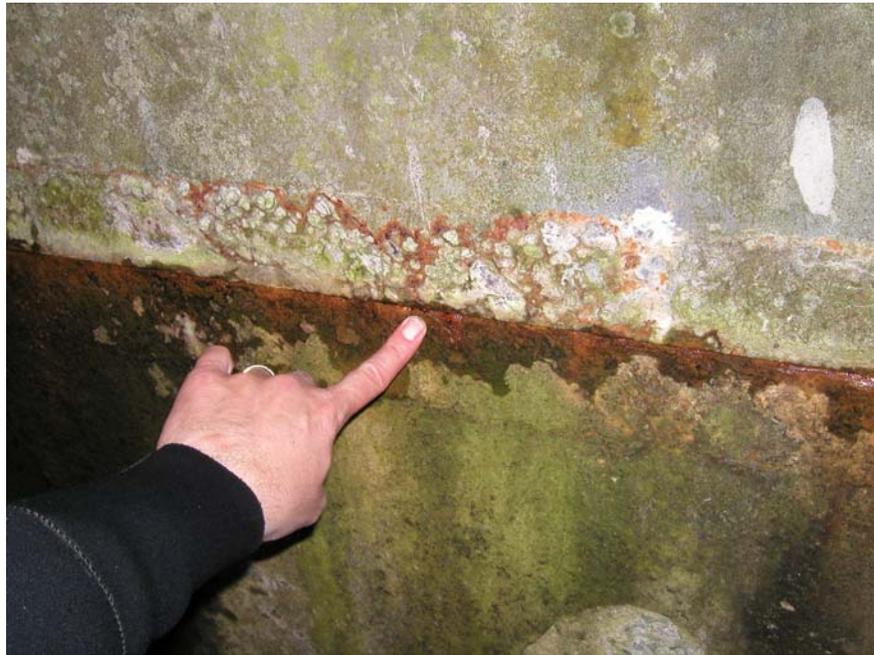
Photograph No. 27. Finger pointing to seepage through horizontal lift line of the stoplogs in the left side of the double barrel diversion conduit. PN Regional Underwater Inspection Team – JC Boyle, Copco 1, and Iron Gate Dams, Klamath Hydroelectric Project, Oregon – California – April 12-16, 2010.

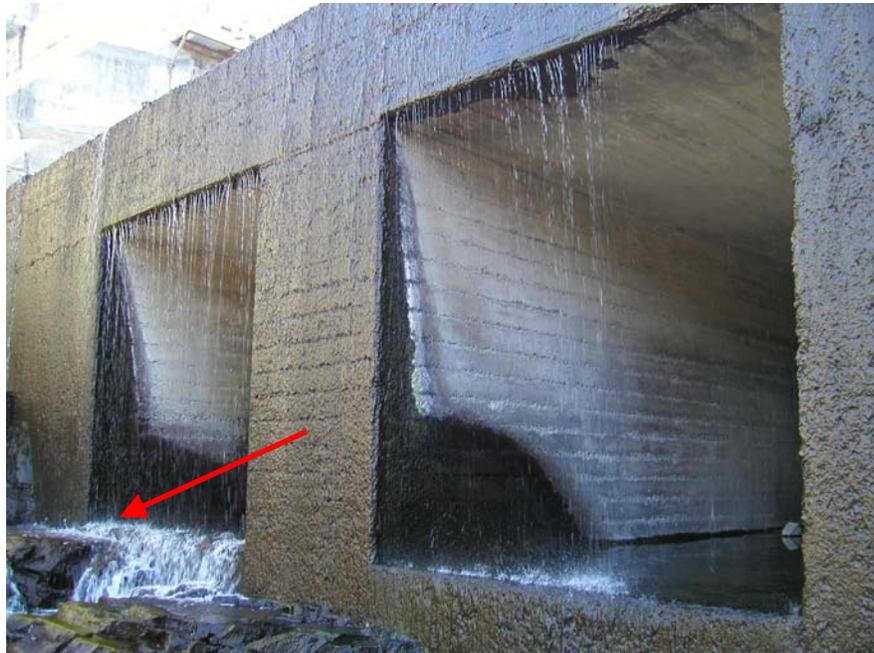
Photograph No. 28. Close-up view of double barrel diversion conduit exit. Note surface flow exiting right side conduit (red arrow). Stoplogs on right side are racked in the guide slot causing leakage. Significant P-Delta effects were noted by divers at this location. Extreme caution and distance should be maintained by any future dive team to this area. PN Regional Underwater Inspection Team – JC Boyle, Copco 1, and Iron Gate Dams, Klamath Hydroelectric Project, Oregon – California – April 12-16, 2010.

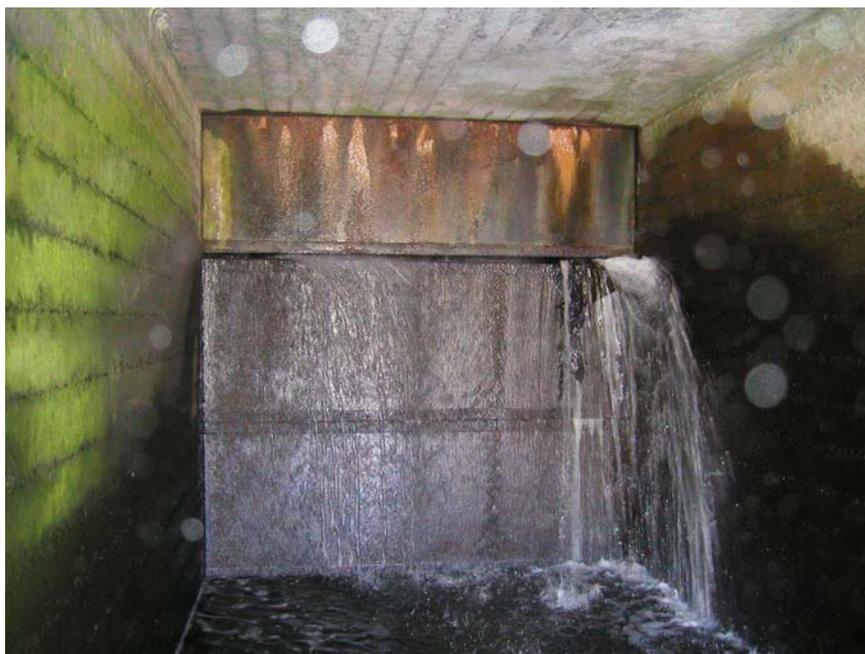
Photograph No. 29. Upstream view on right side of double barrel diversion conduit showing flow through the concrete stoplog. P-Delta effects were noted by divers on the upstream side of this structure. PN Regional Underwater Inspection Team – JC Boyle Copco 1, and Iron Gate Dams, Klamath Hydroelectric Project, Oregon – California – April 12-16, 2010.

At JC Boyle Dam the grassy weed material in front of the power intake structure is apparently a constant problem. PacifiCorp has in place and should maintain their current procedure for removal of this material on a regular basis. The concrete was found to be in good condition with no spalling or exposed rebar noted. Divers in future diving operations, in and around the right

side of the double barrel diversion conduit, should be briefed on the leakage and possible P-Delta effects of working in this area.

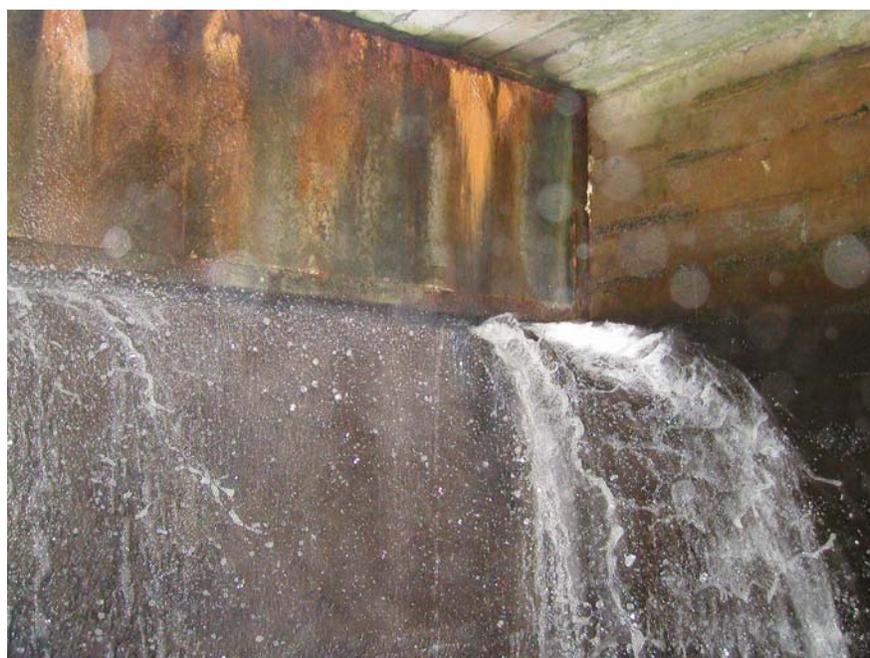
Photograph No. 30. Flow through the stoplogs on the right side of the double barrel diversion conduit. PN Regional Underwater Inspection Team – JC Boyle, Copco 1, and Iron Gate Dams, Klamath Hydroelectric Project, Oregon – California – April 12-16, 2010.

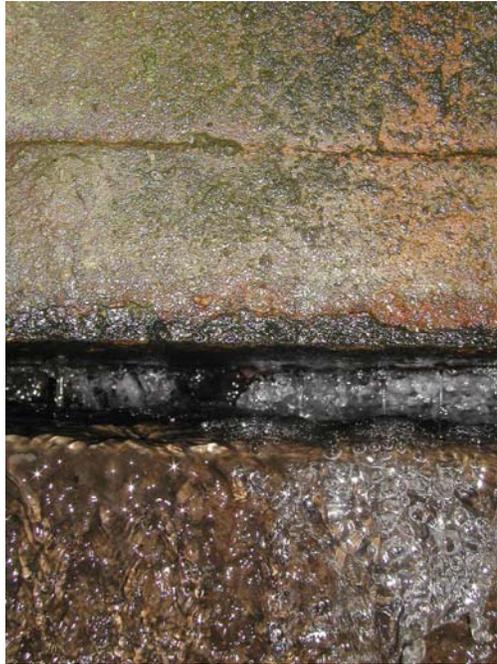
Photograph No. 31. Close-up of flow through the stoplogs on the right side of the double barrel diversion conduit. PN Regional Underwater Inspection Team – JC Boyle, Copco 1, and Iron Gate Dams, Klamath Hydroelectric Project, Oregon – California – April 12-16, 2010.
