Dive Report

Subject: Submission of Dive Report

Attached is the Dive Report for the Underwater Examination of the Structures and Collection of Sediment Samples at Iron Gate, Copco 1, and JC Boyle Dams which was performed by the PN Regional Underwater Inspection Team from April 12 through 16, 2010.

Iron Gate Dam, Klamath Hydroelectric Project, California

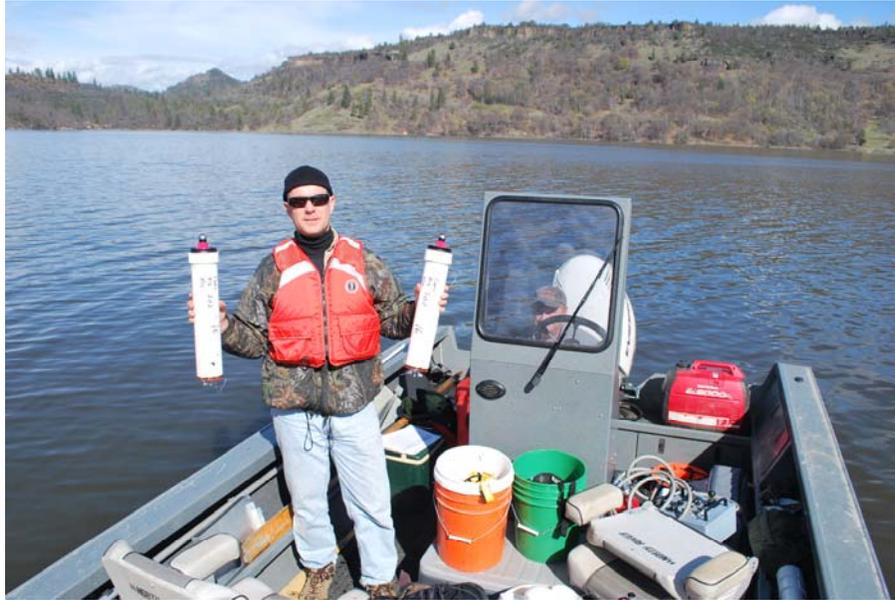
Photograph No. 1. Paul Zedonis (USFWS) showing arrangement and orientation required for proper delivery of sediment sampling tubes to the surface. PN Regional Underwater Inspection Team – JC Boyle, Copco 1, and Iron Gate Dams, Klamath Hydroelectric Project, Oregon – California – April 12-16, 2010.

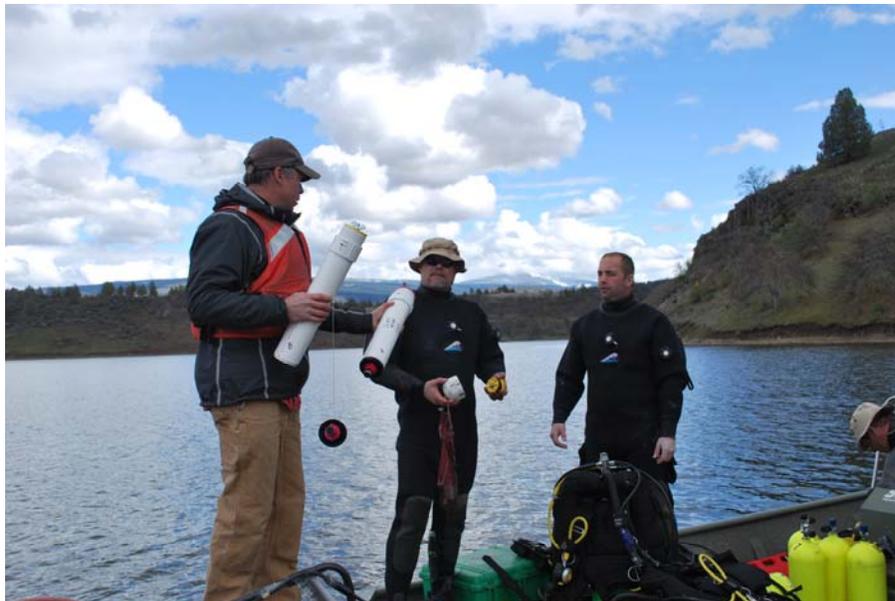
Photograph No. 2. Chauncey Anderson (USGS) providing divers with pre-dive briefing to go over requirements for adequate sampling of river bottom. PN Regional Underwater Inspection Team – JC Boyle, Copco 1, and Iron Gate Dams, Klamath Hydroelectric Project, Oregon – California – April 12-16, 2010.

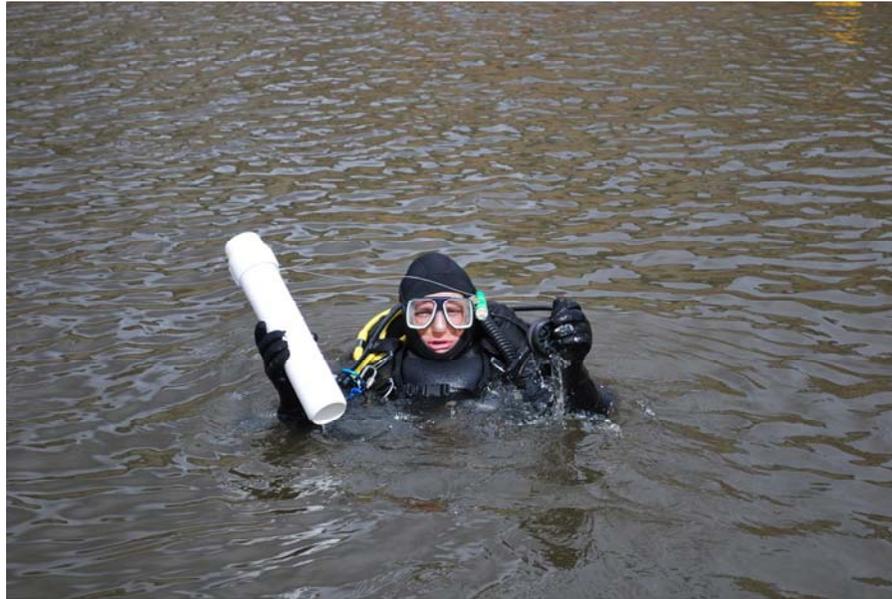
Photograph No. 3. Diver with sediment sampling tube in hand preparing to descend for sediment retrieval. PN Regional Underwater Inspection Team – JC Boyle, Copco 1, and Iron Gate Dams, Klamath Hydroelectric Project, Oregon – California – April 12-16, 2010.

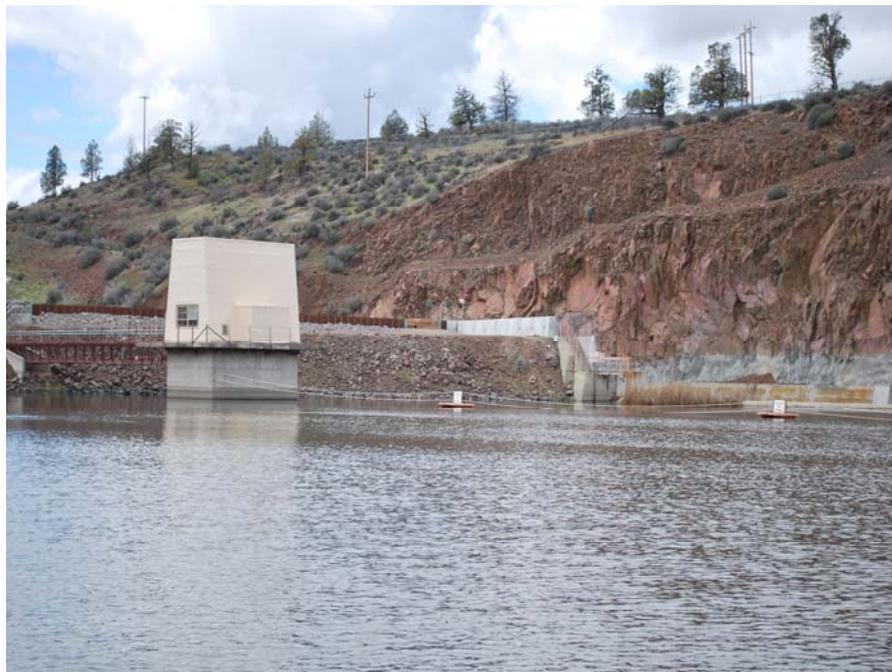
Photograph No. 4. Right abutment of Iron Gate dam at approximate location for deployment of ROV used to survey intake structure. PN Regional Underwater Inspection Team – JC Boyle, Copco 1, and Iron Gate Dams, Klamath Hydroelectric Project, Oregon – California – April 12-16, 2010.

The intake structure at Iron Gate Dam should be periodically inspected by ROV to determine if the rust nodules and algae growth are increasing with time, possibly reducing the structure's capacity to release flows. At this time it did not appear the capacity of the intake structure is reduced. The intake concrete appeared to be in satisfactory condition.

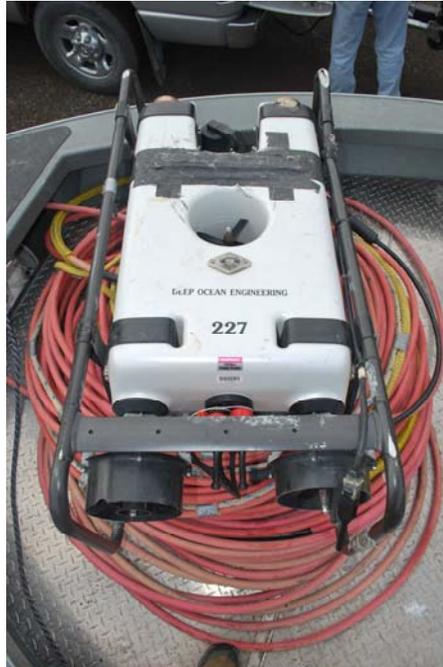
Photograph No. 5. PN Dive Team Deep Ocean Engineering ROV. PN Regional Underwater Inspection Team – JC Boyle, Copco 1, and Iron Gate Dams, Klamath Hydroelectric Project, Oregon – California – April 12-16, 2010.

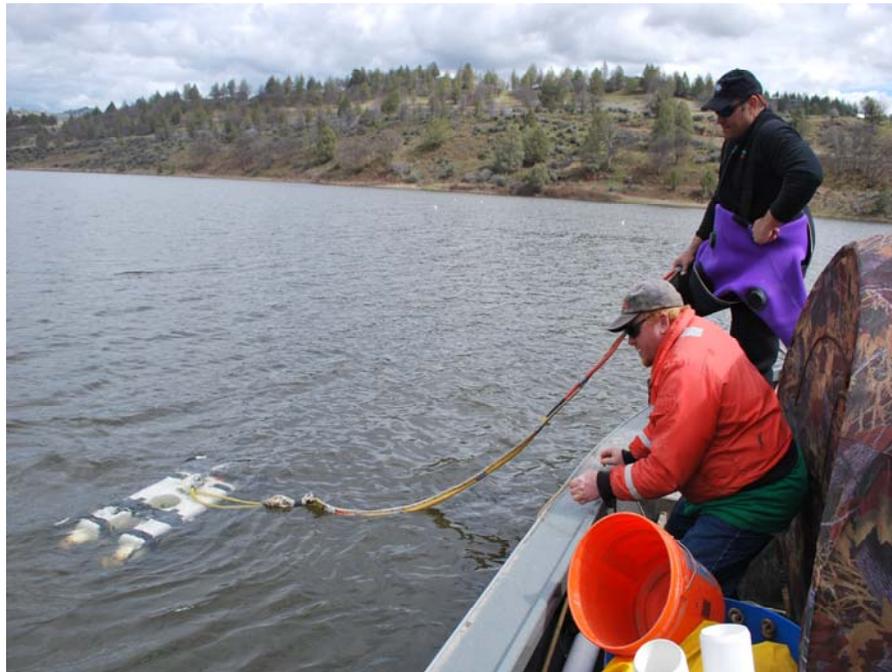
Photograph No. 6. ROV on surface with surface support personnel tending descent and ascent of vehicle. PN Regional Underwater Inspection Team – JC Boyle, Copco 1, and Iron Gate Dams, Klamath Hydroelectric Project, Oregon – California – April 12-16, 2010.

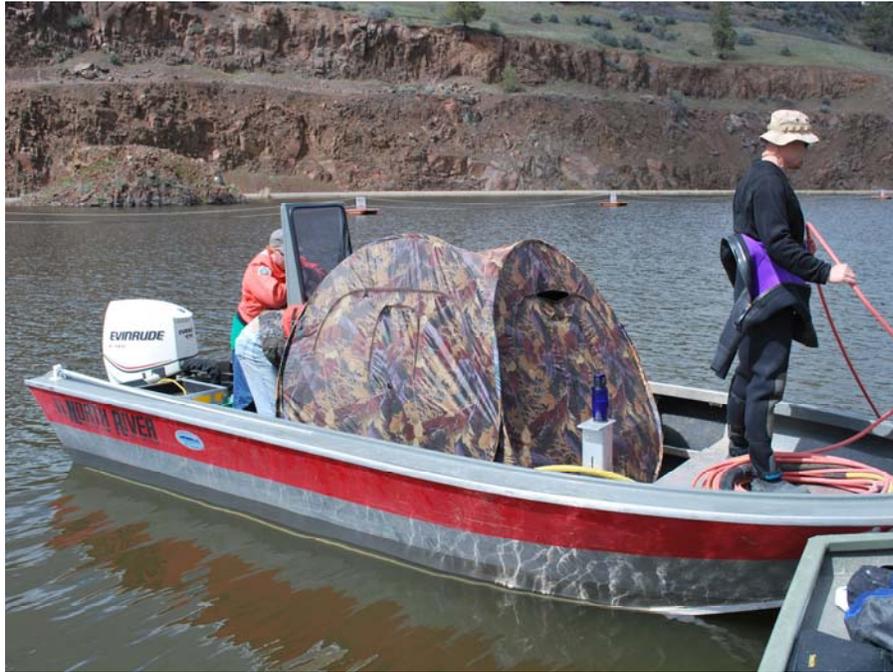
Photograph No. 7. Hunting blind used for ROV video monitor. PN Regional Underwater Inspection Team – JC Boyle, Copco 1, and Iron Gate Dams, Klamath Hydroelectric Project, Oregon – California – April 12-16, 2010.

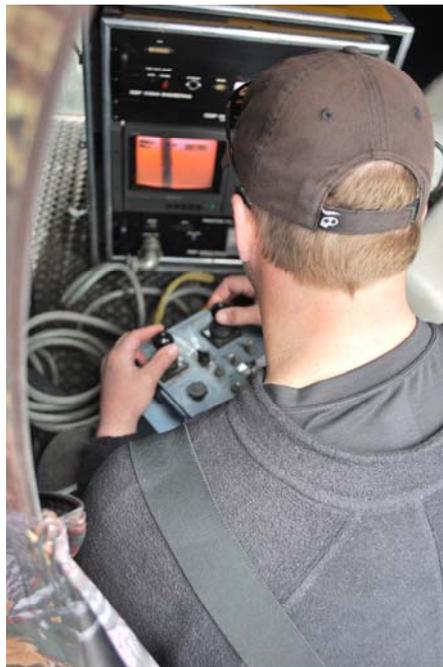
Photograph No. 8. View of ROV controls and video display unit. PN Regional Underwater Inspection Team – JC Boyle, Copco 1, and Iron Gate Dams, Klamath Hydroelectric Project, Oregon – California – April 12-16, 2010.

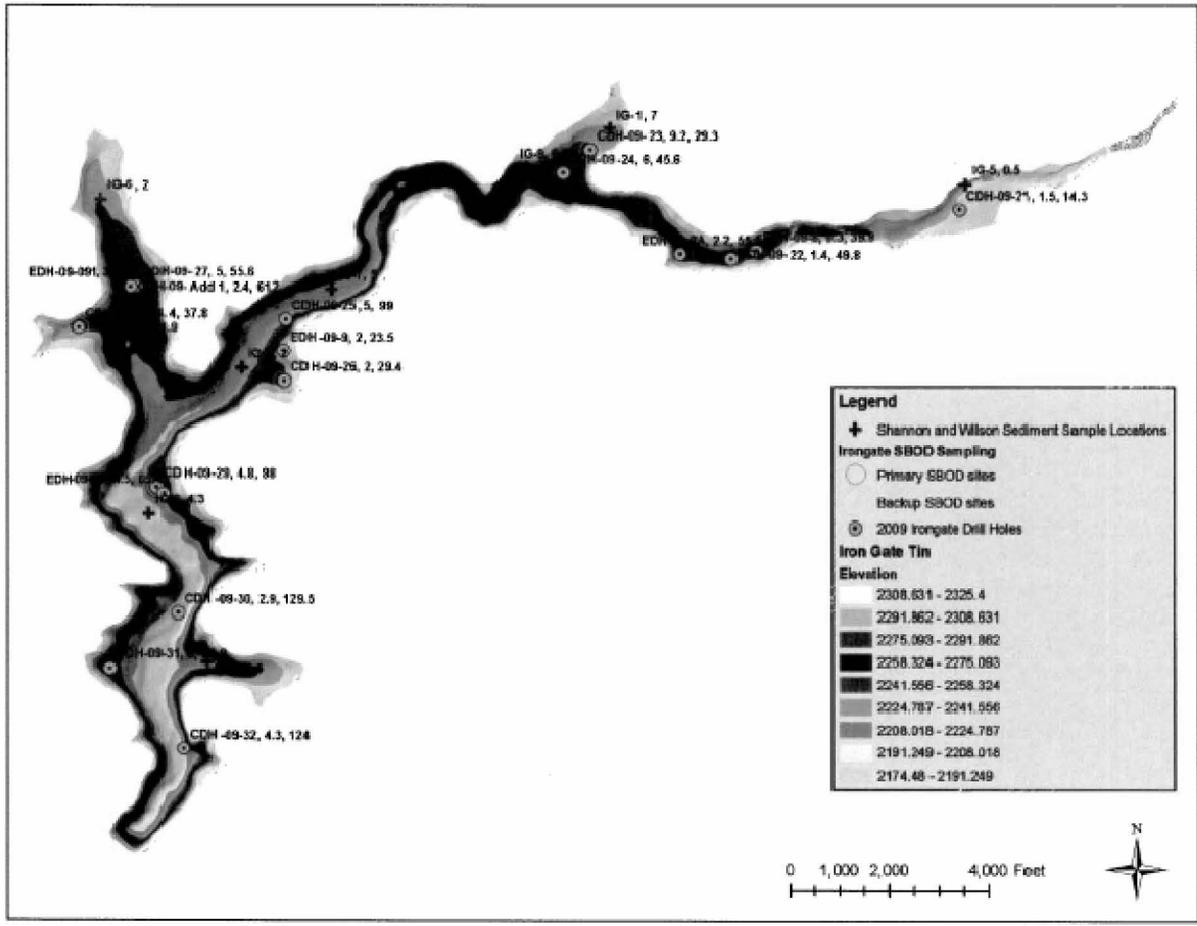
FIGURE 1

Iron Gate Reservoir map showing approximate locations of sampling sites.

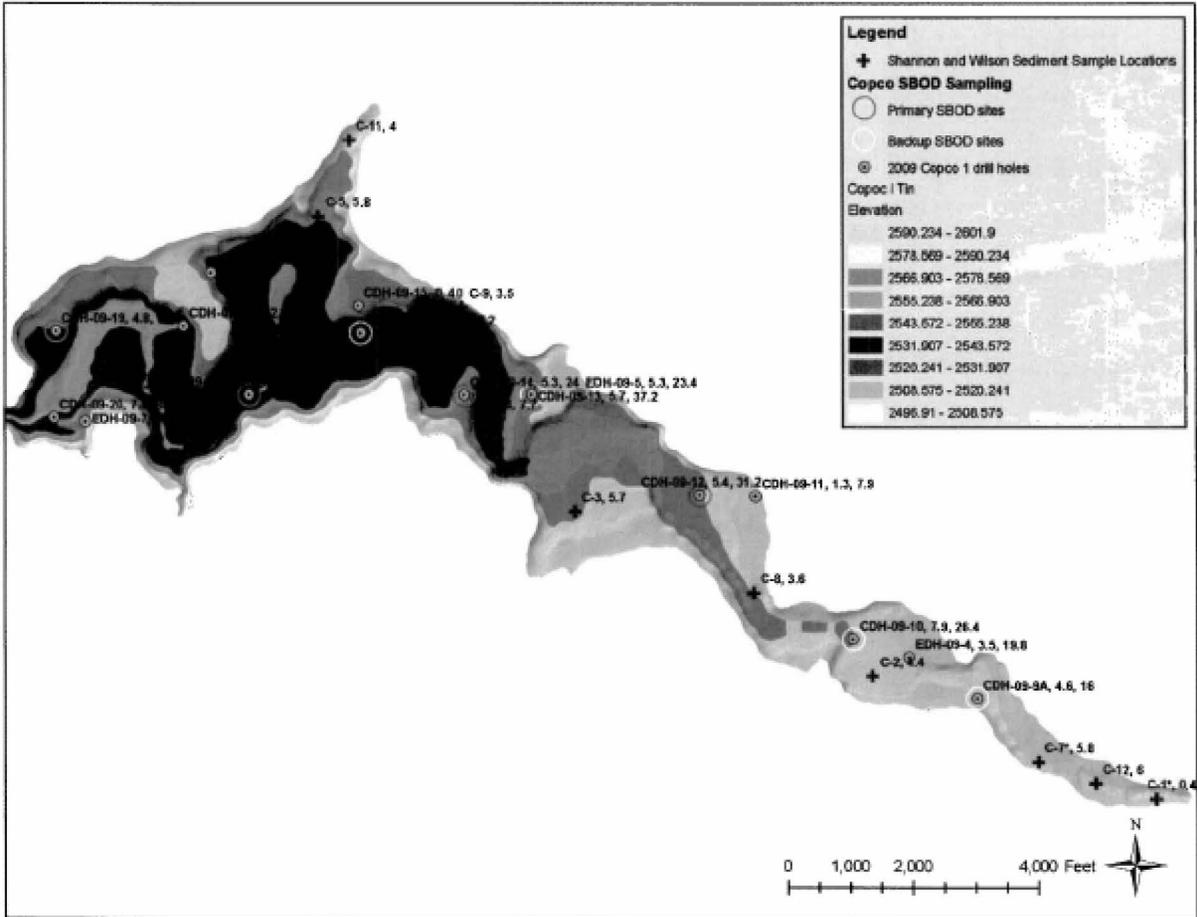
FIGURE 2

Copco Reservoir map showing approximate locations of sampling sites.
